# **TRAUMA CASE OF THE WEEK**

**Case Two**

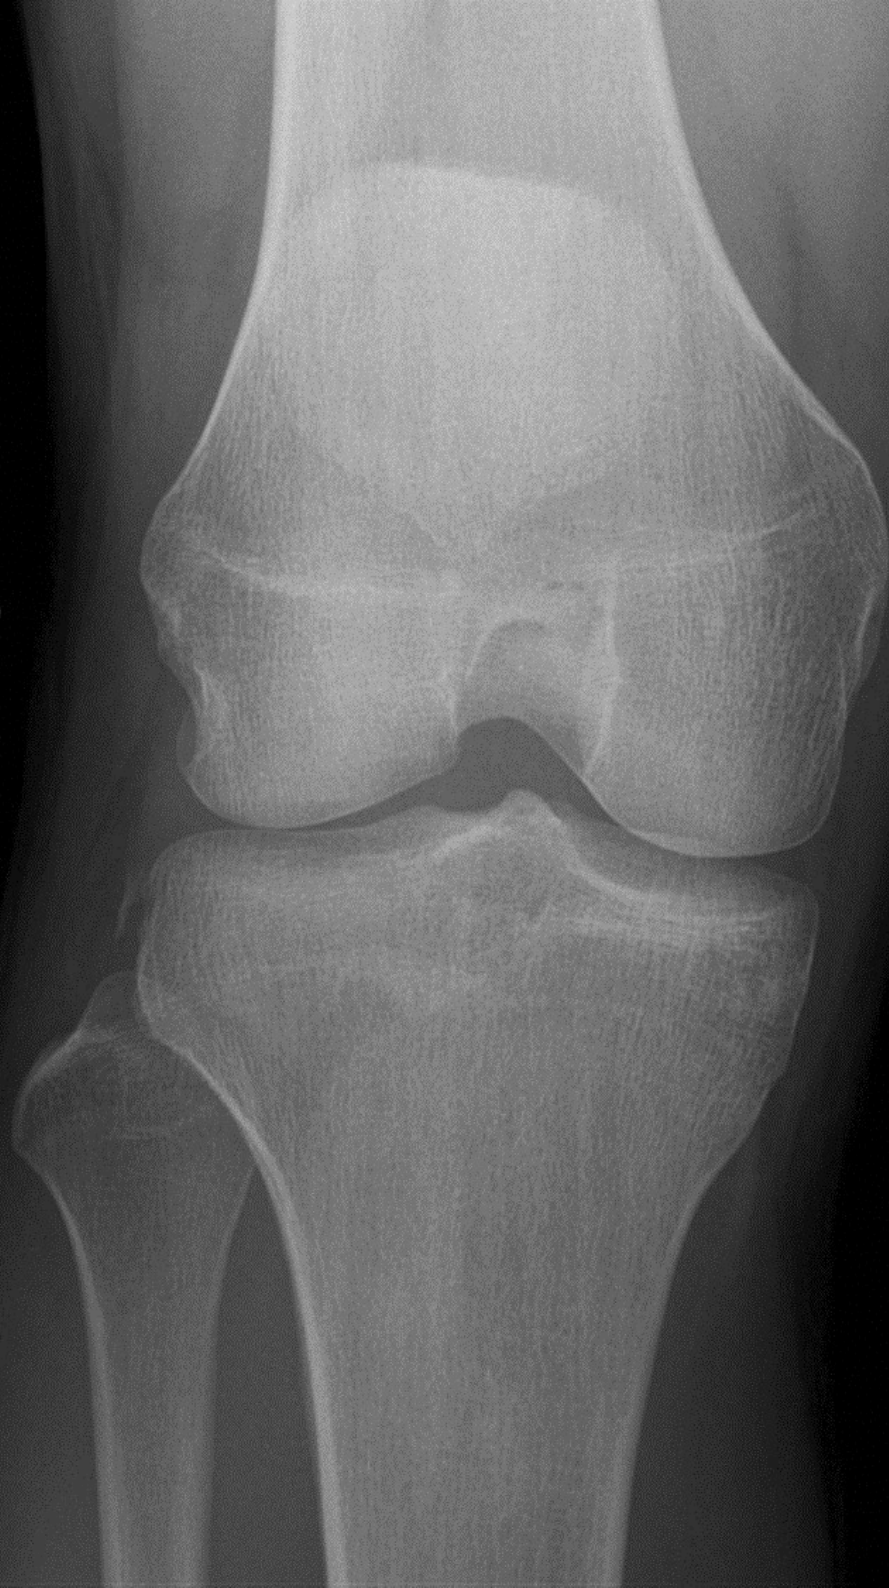
R  
JB

**The Xray findings are subtle and consist of a fine bone fragment (about 10mm long and up to 4mm wide) seen at the border of the upper part of the lateral tibial plateau. This is a so called “Segond” fracture. This unimpressive radiographic finding doesn’t reflect the severity of the underlying knee injury. The mechanism of the Segond fracture is a combination of bowing and twisting (technically a combination of varus stress and internal tibial rotation) of the knee. The bone fragment seen is an avulsion fracture from the lateral ligament complex, but the real significance is that there are usually also injuries to the anterior cruciate and medial meniscus. So, it represents a major knee joint disruption with potential for significant instability. A missed anterior cruciate injury can have life-long implications, leading to chronic instability and pain ... so the presence of a Segond fracture should set a bomb off in our heads! Such patients should have an early orthopaedic referral, and likely to require an MRI.**
